COMPTON HILL RESERVOIR

ST. LOUIS, MISSOURI

MO 31696

PHASE 1 INSPECTION REPORT NATIONAL DAM SAFETY PROGRAM

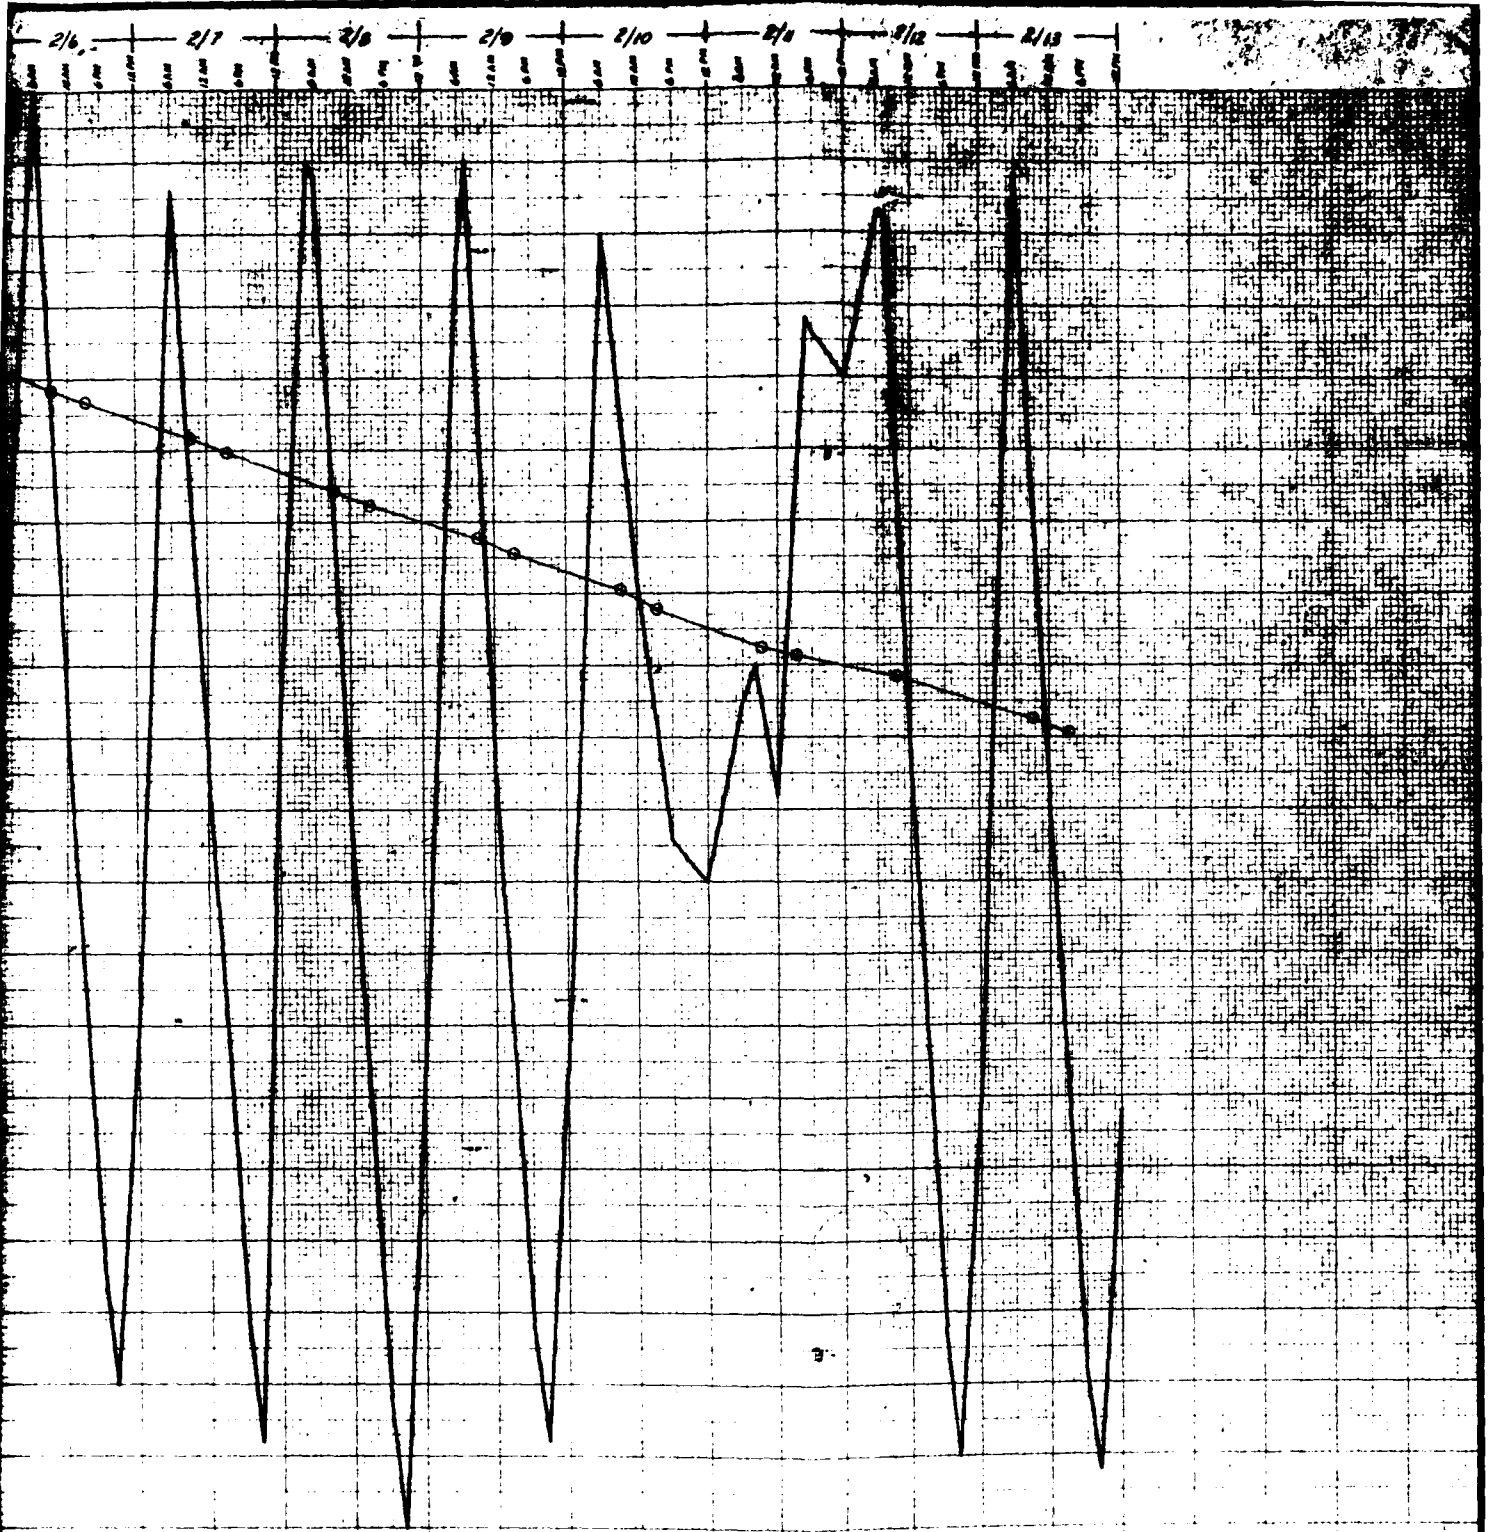
LEAKAGE RESULTS
COMPTON HILL
SOUTH BASIN

TOTAL LOSS: 4.34 MILLION GALLONS

AVG. LOSS: .526 MGD

CALCULATED LEAK: .475 MGD

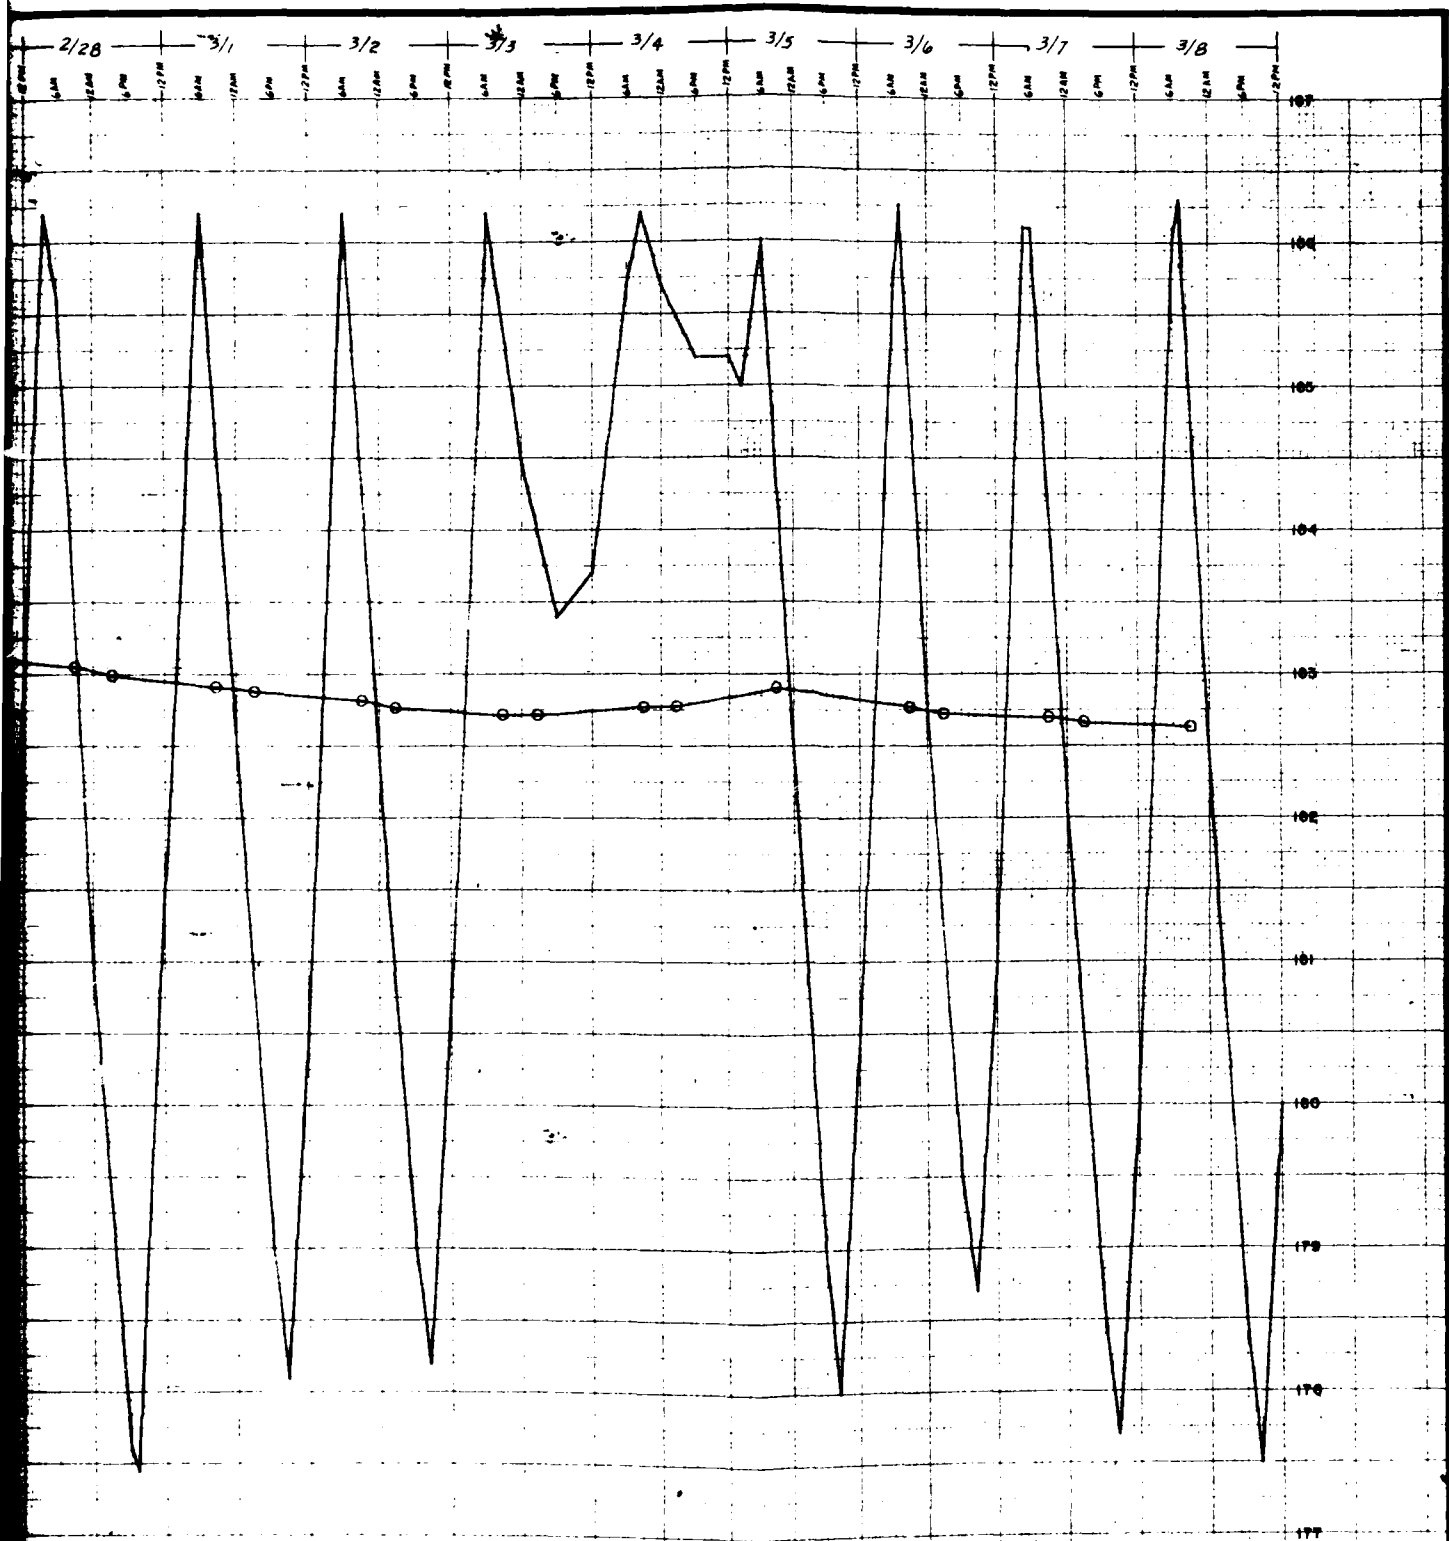
TOTAL LOSS: 1834 MILLION GALLONS

AVG. LOSS: .115 MGD

CALCULATED LEAK: .093 MGD
